## **FAC 1166 Miscellaneous Airfield Pavement, Unsurfaced**

# Unpaved Runway Sustainment Funding

25 Aug 2011

To provide information and considerations related to sustainment of Unpaved Runways

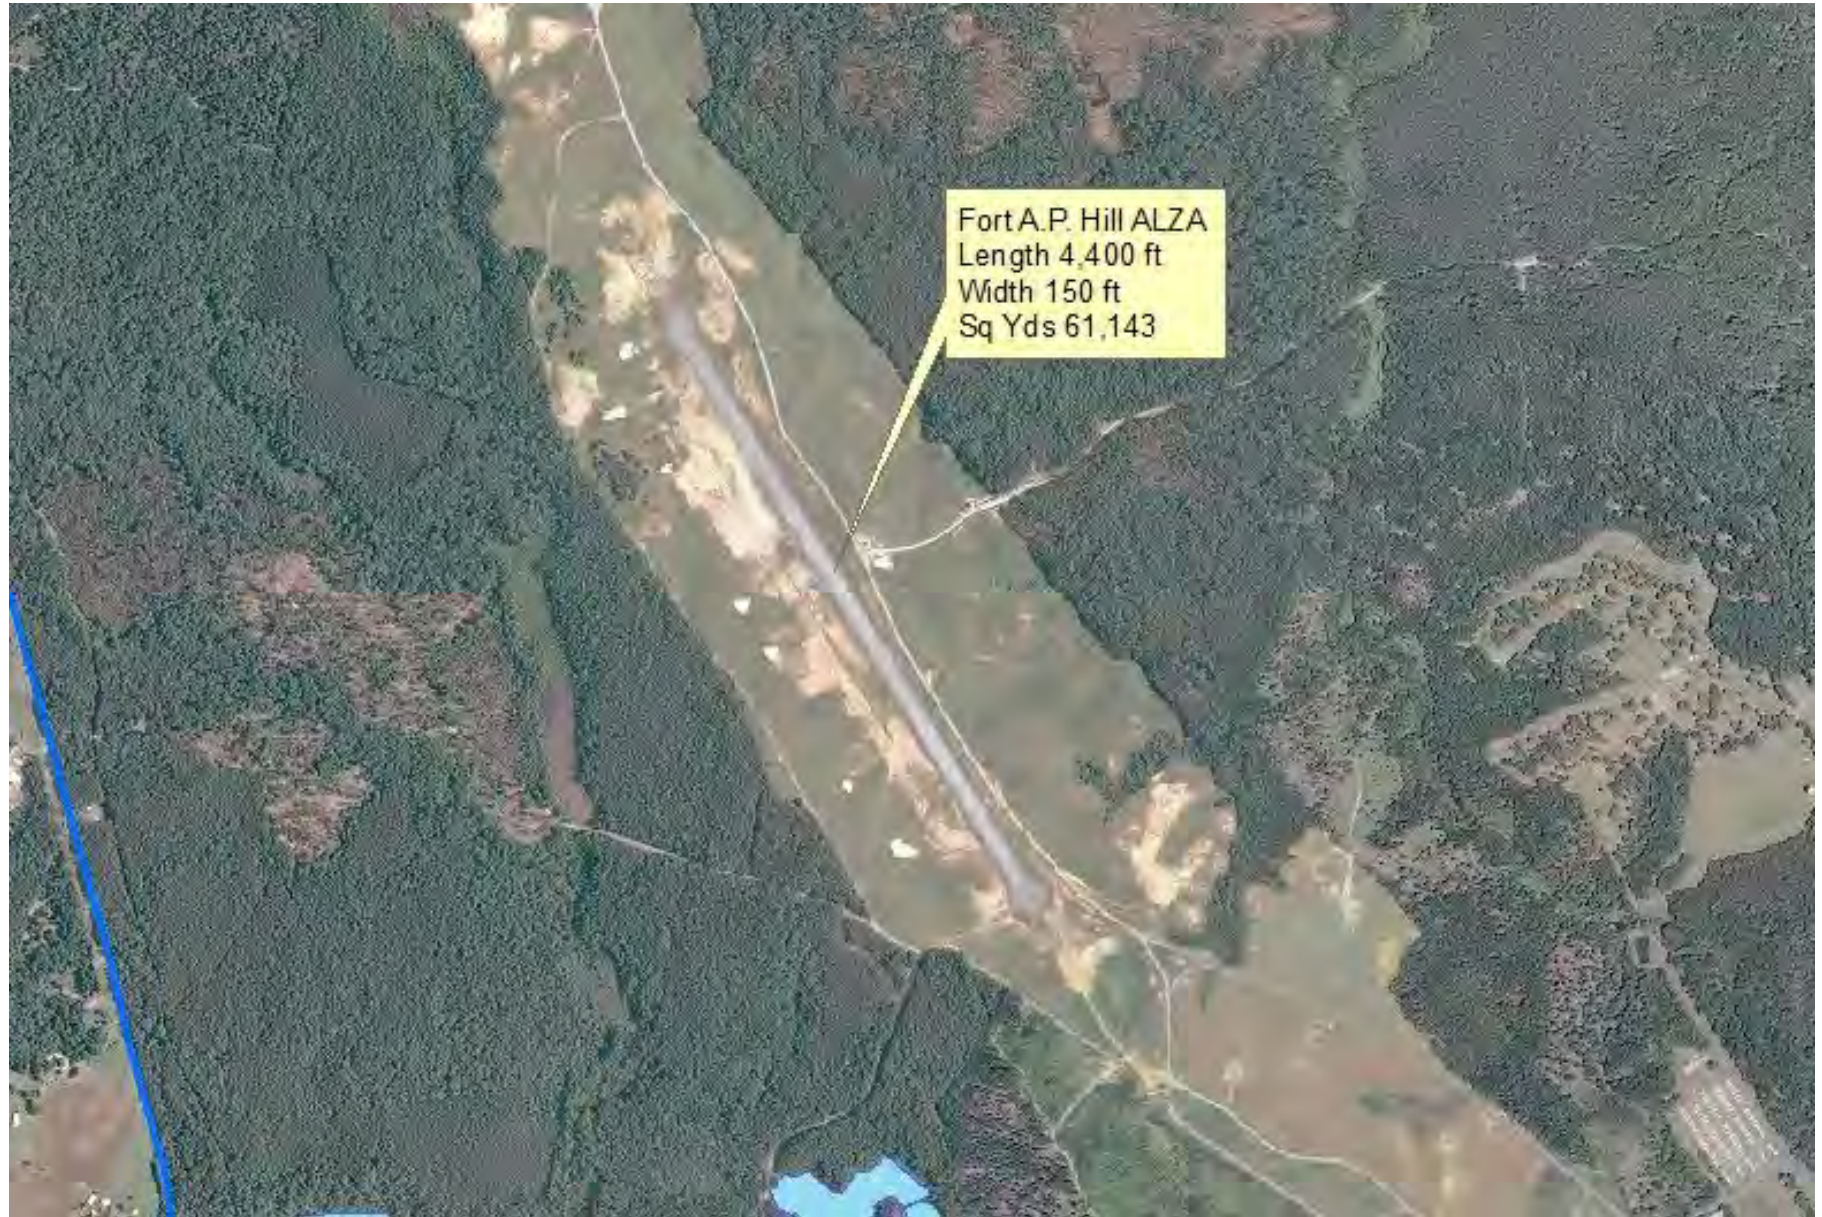
# FAPH ALZA RPID 272037 – FCC 11111

- FAPH ALZA C130, C17, Twin Otter, DHC-4
  - 4400 Ln ft stone surface
- FAPH AF1- Casa 212, 235, Twin Otter
  - Grass strip
- FAPH PENDER AF- Twin Otter
  - Grass strip
- FAPH COOKE AF- Current ops rotary wing only
  - Grass strip

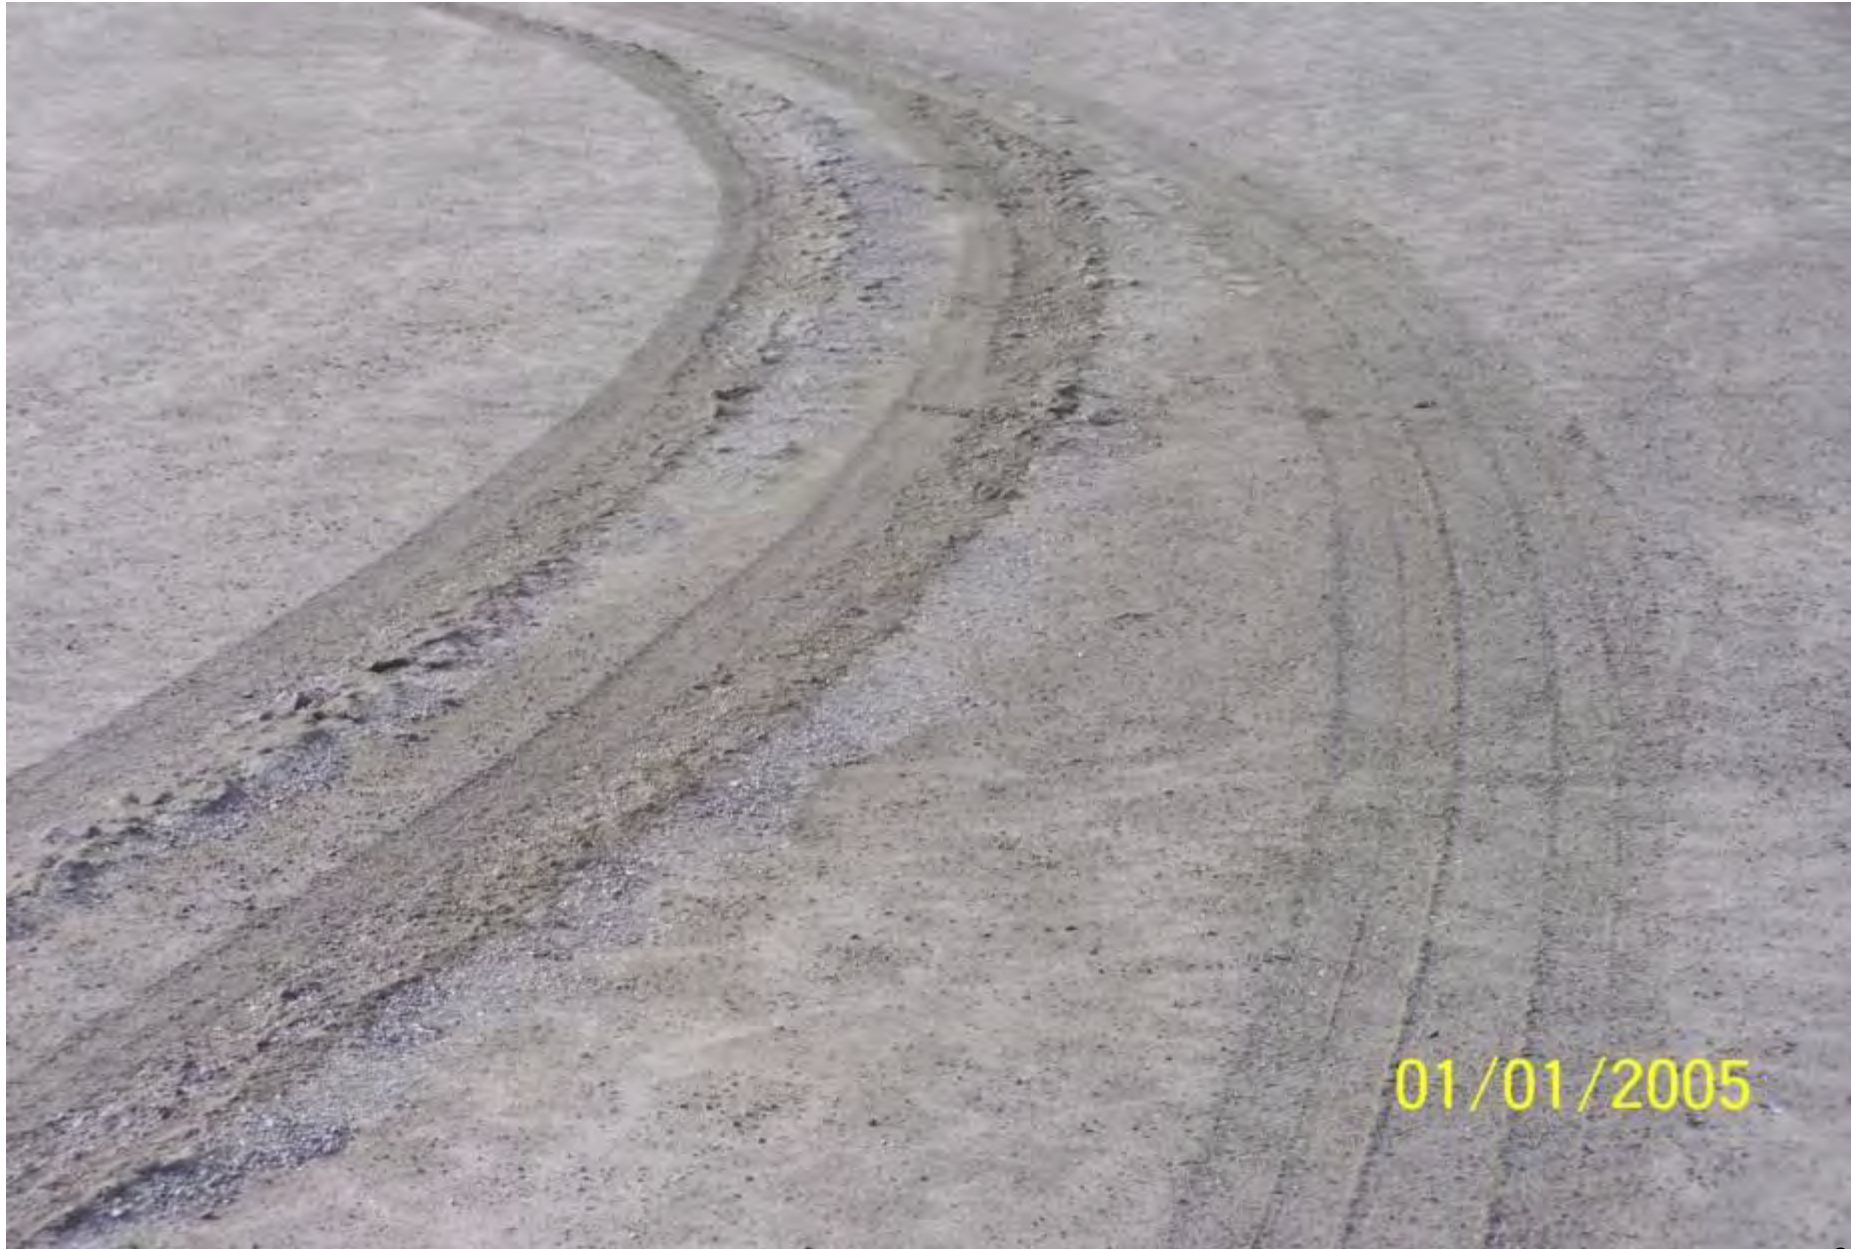
# AP Hill Erosion Example - C17 Turnabout

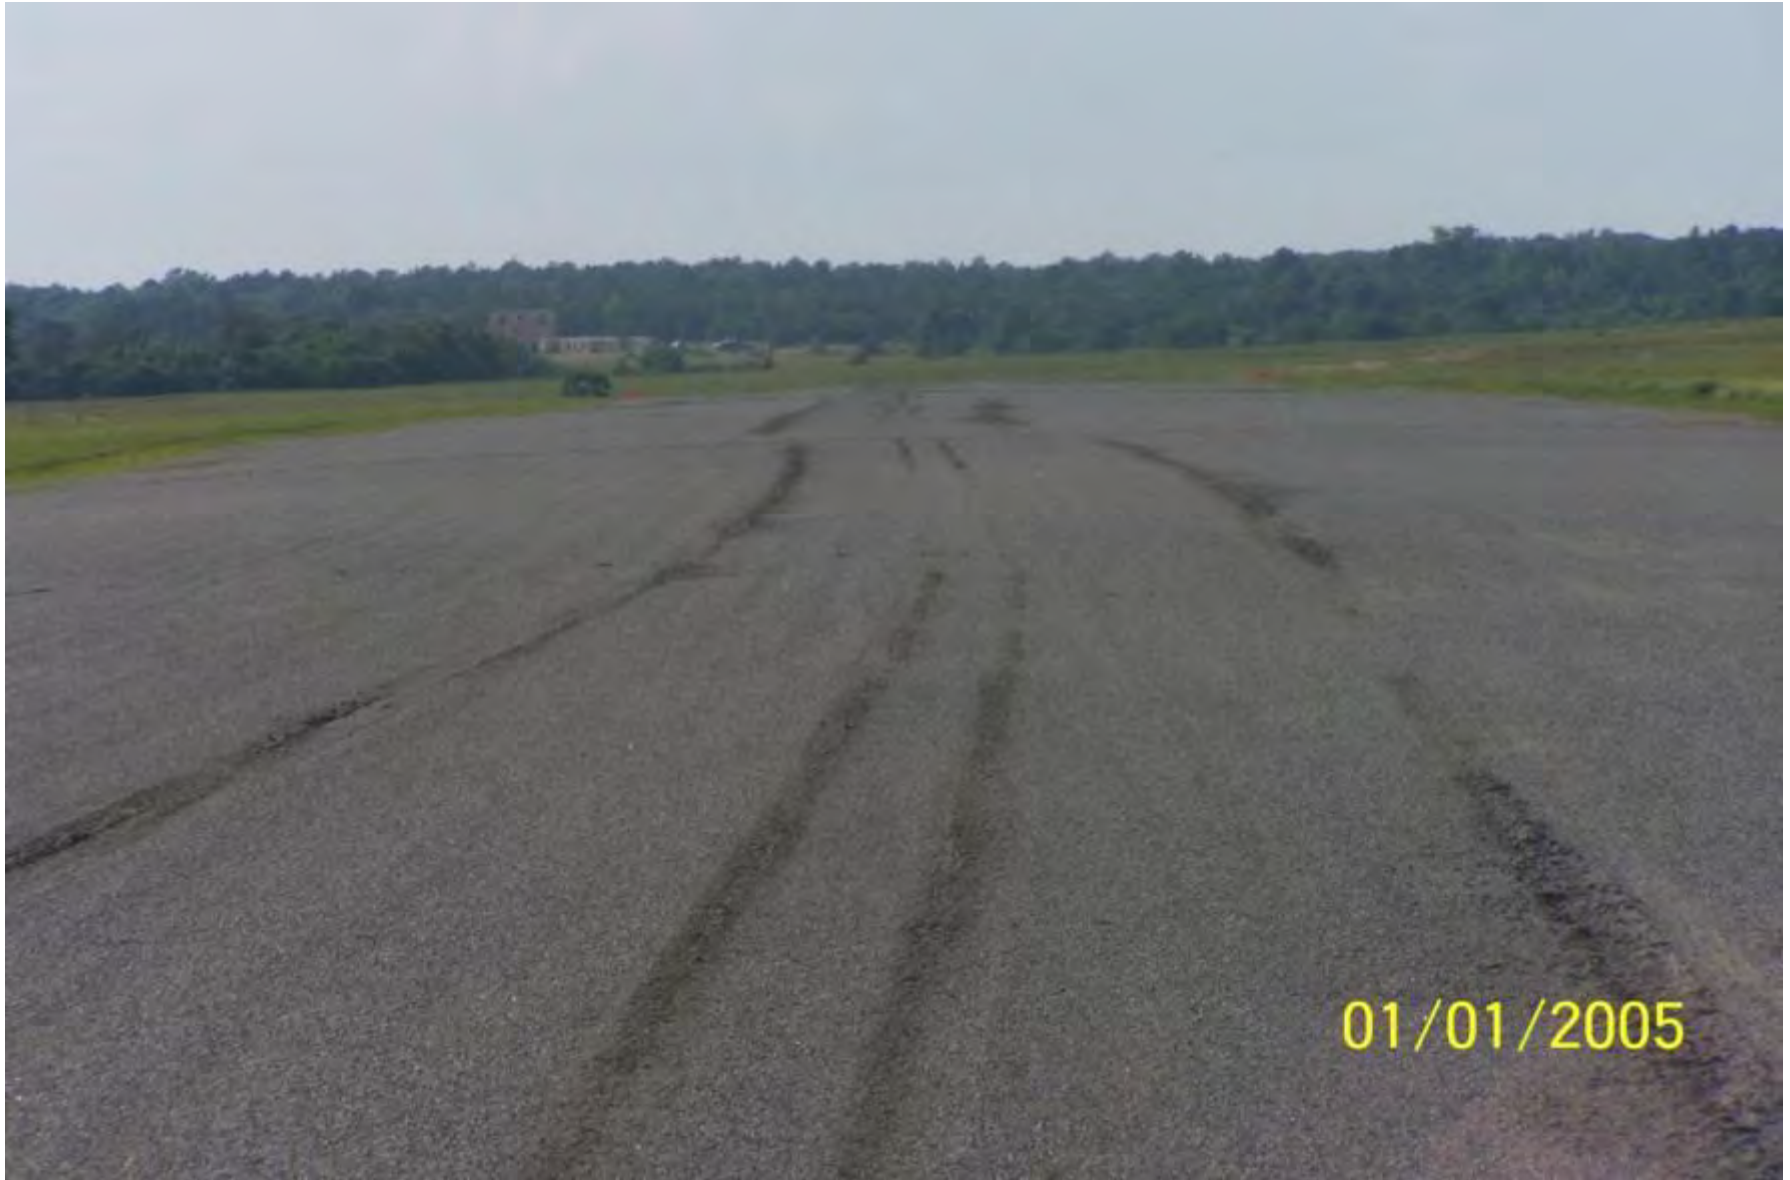
# AP Hill Erosion Example - C17 Rutting

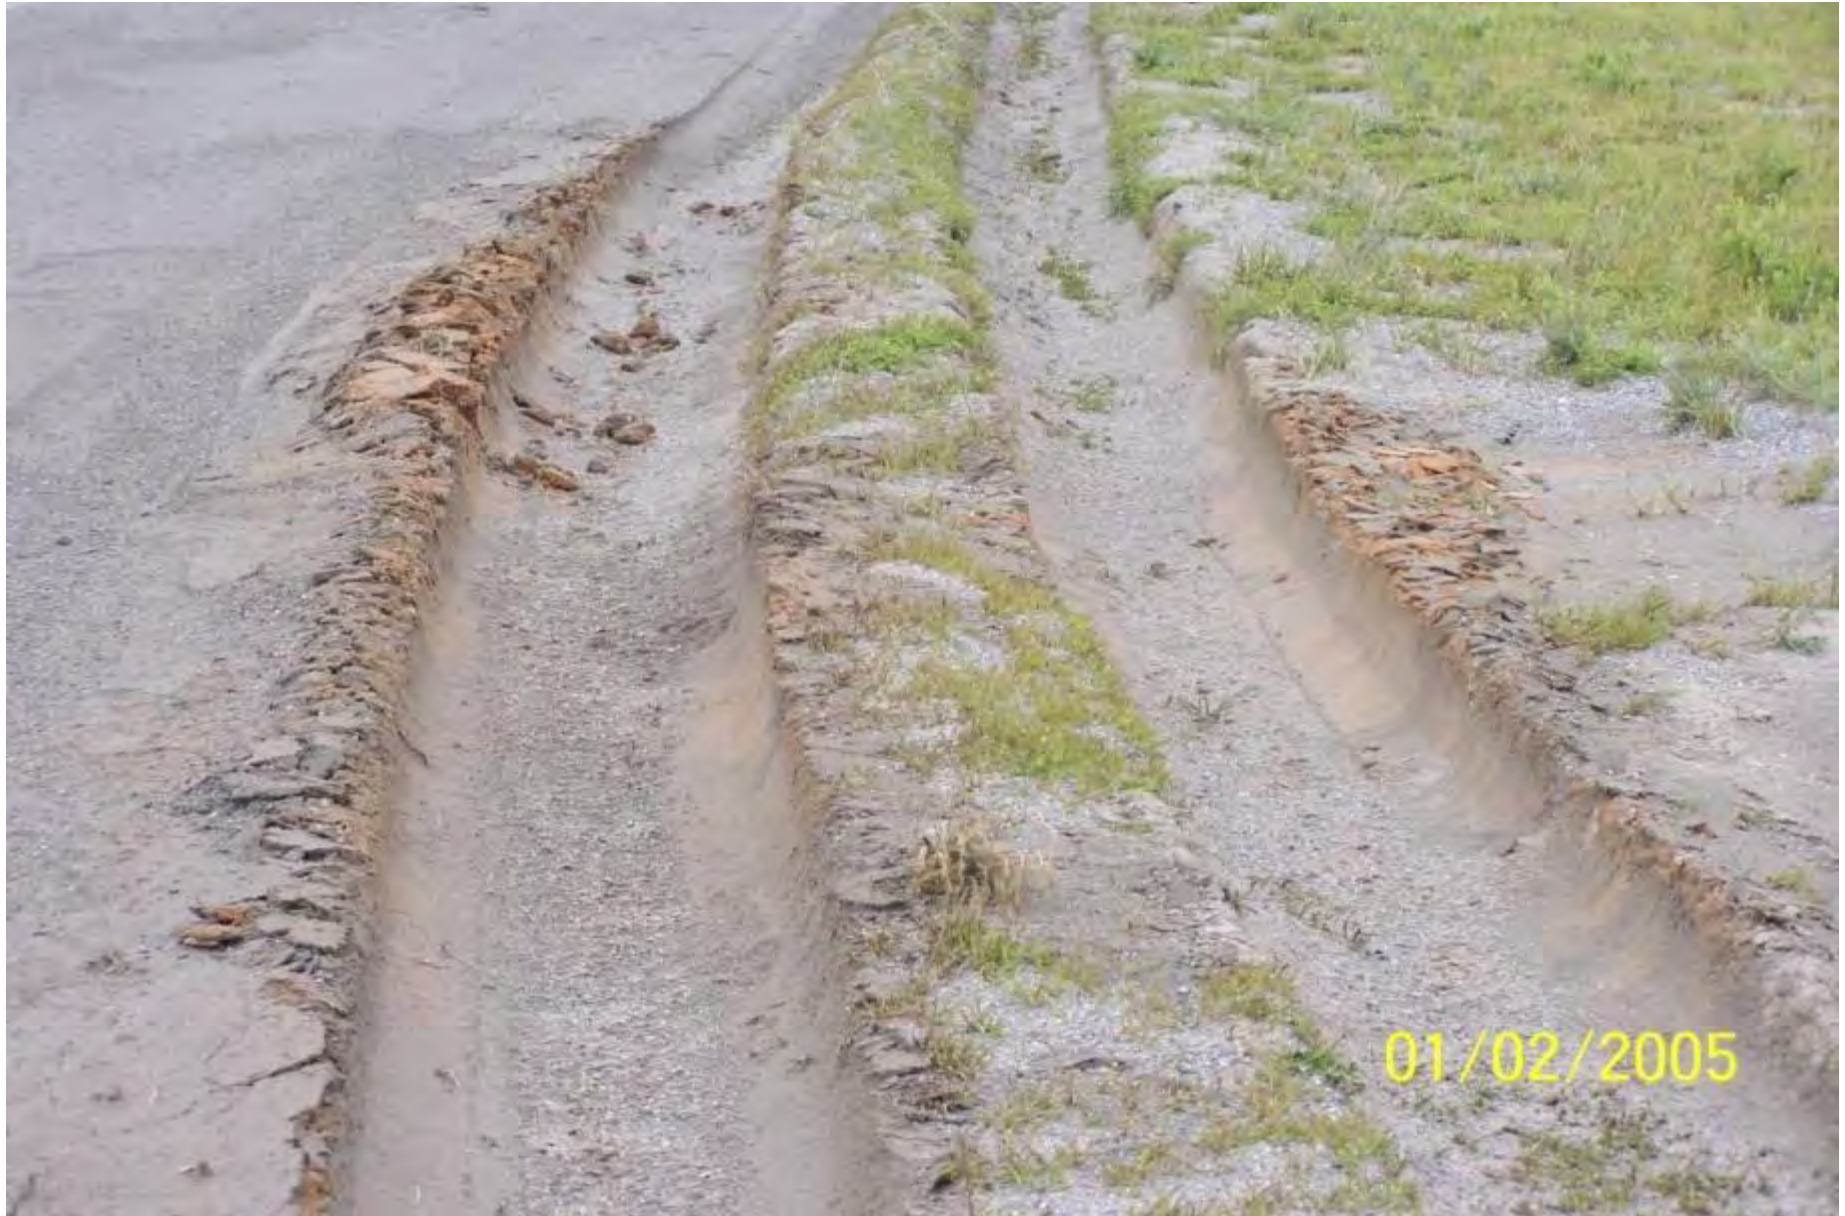
# AP Hill Erosion Example C17 Ruts edge of runway night ops

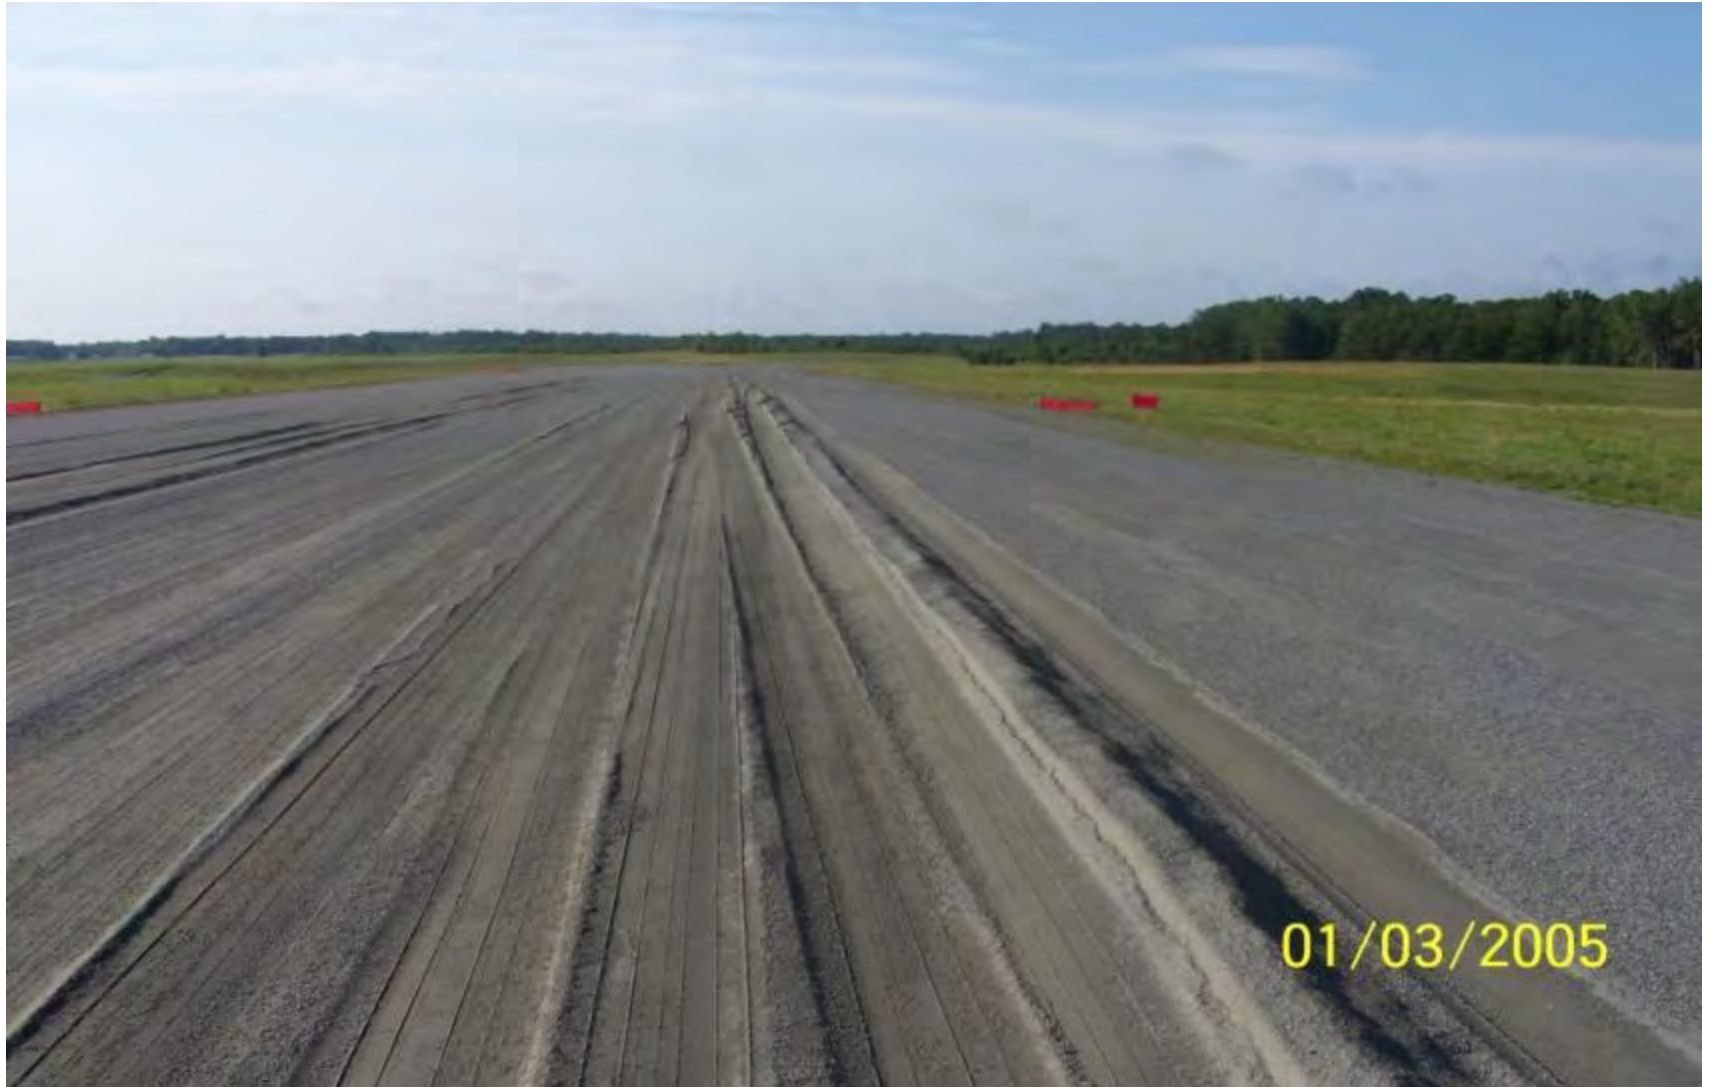
# AP Hill Erosion Example - Typical C17 Effects

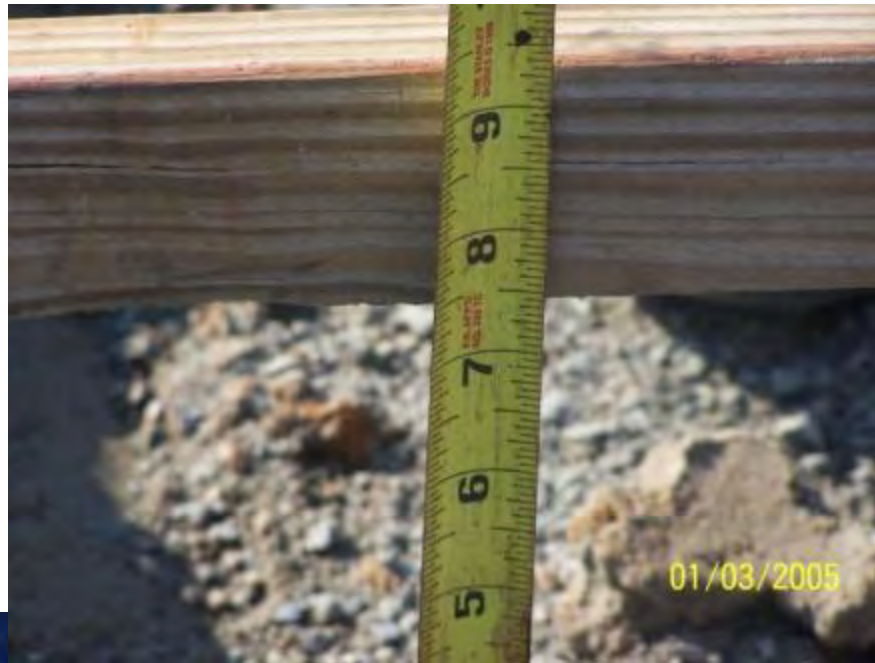
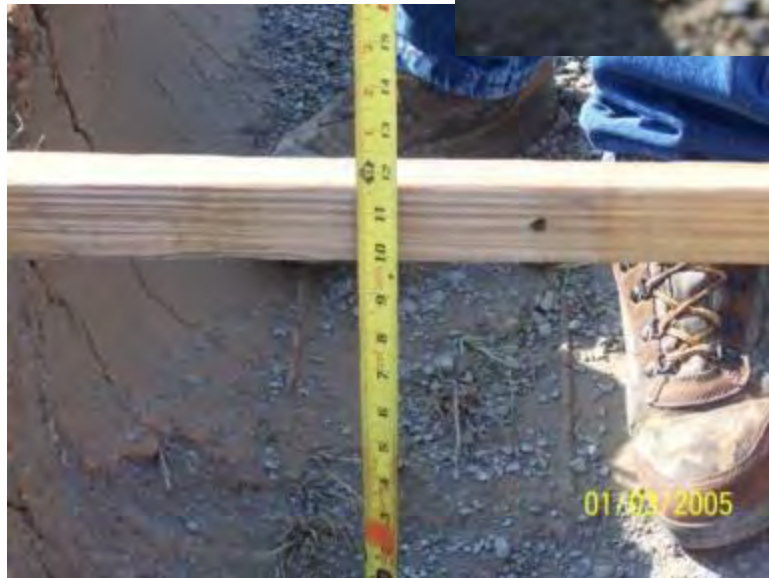
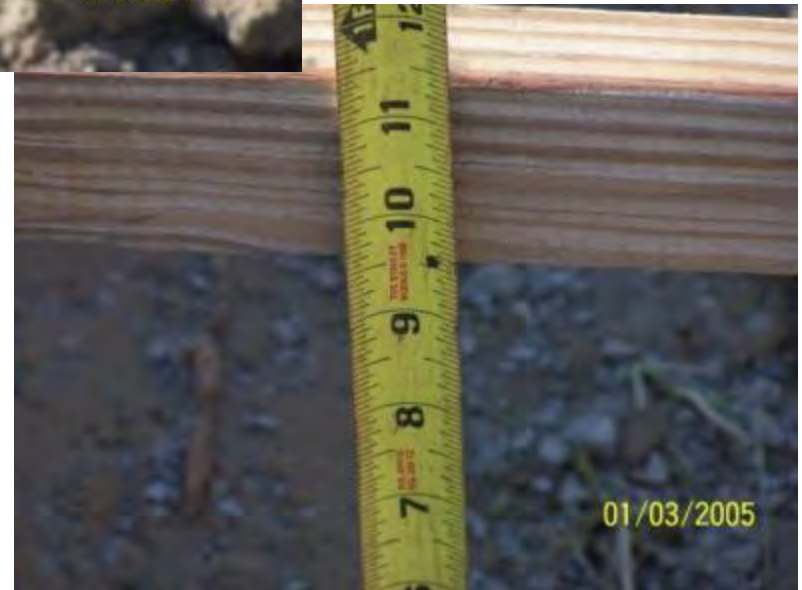
# AP Hill Erosion Example - Average ruts 7.5 to 9.5 inches

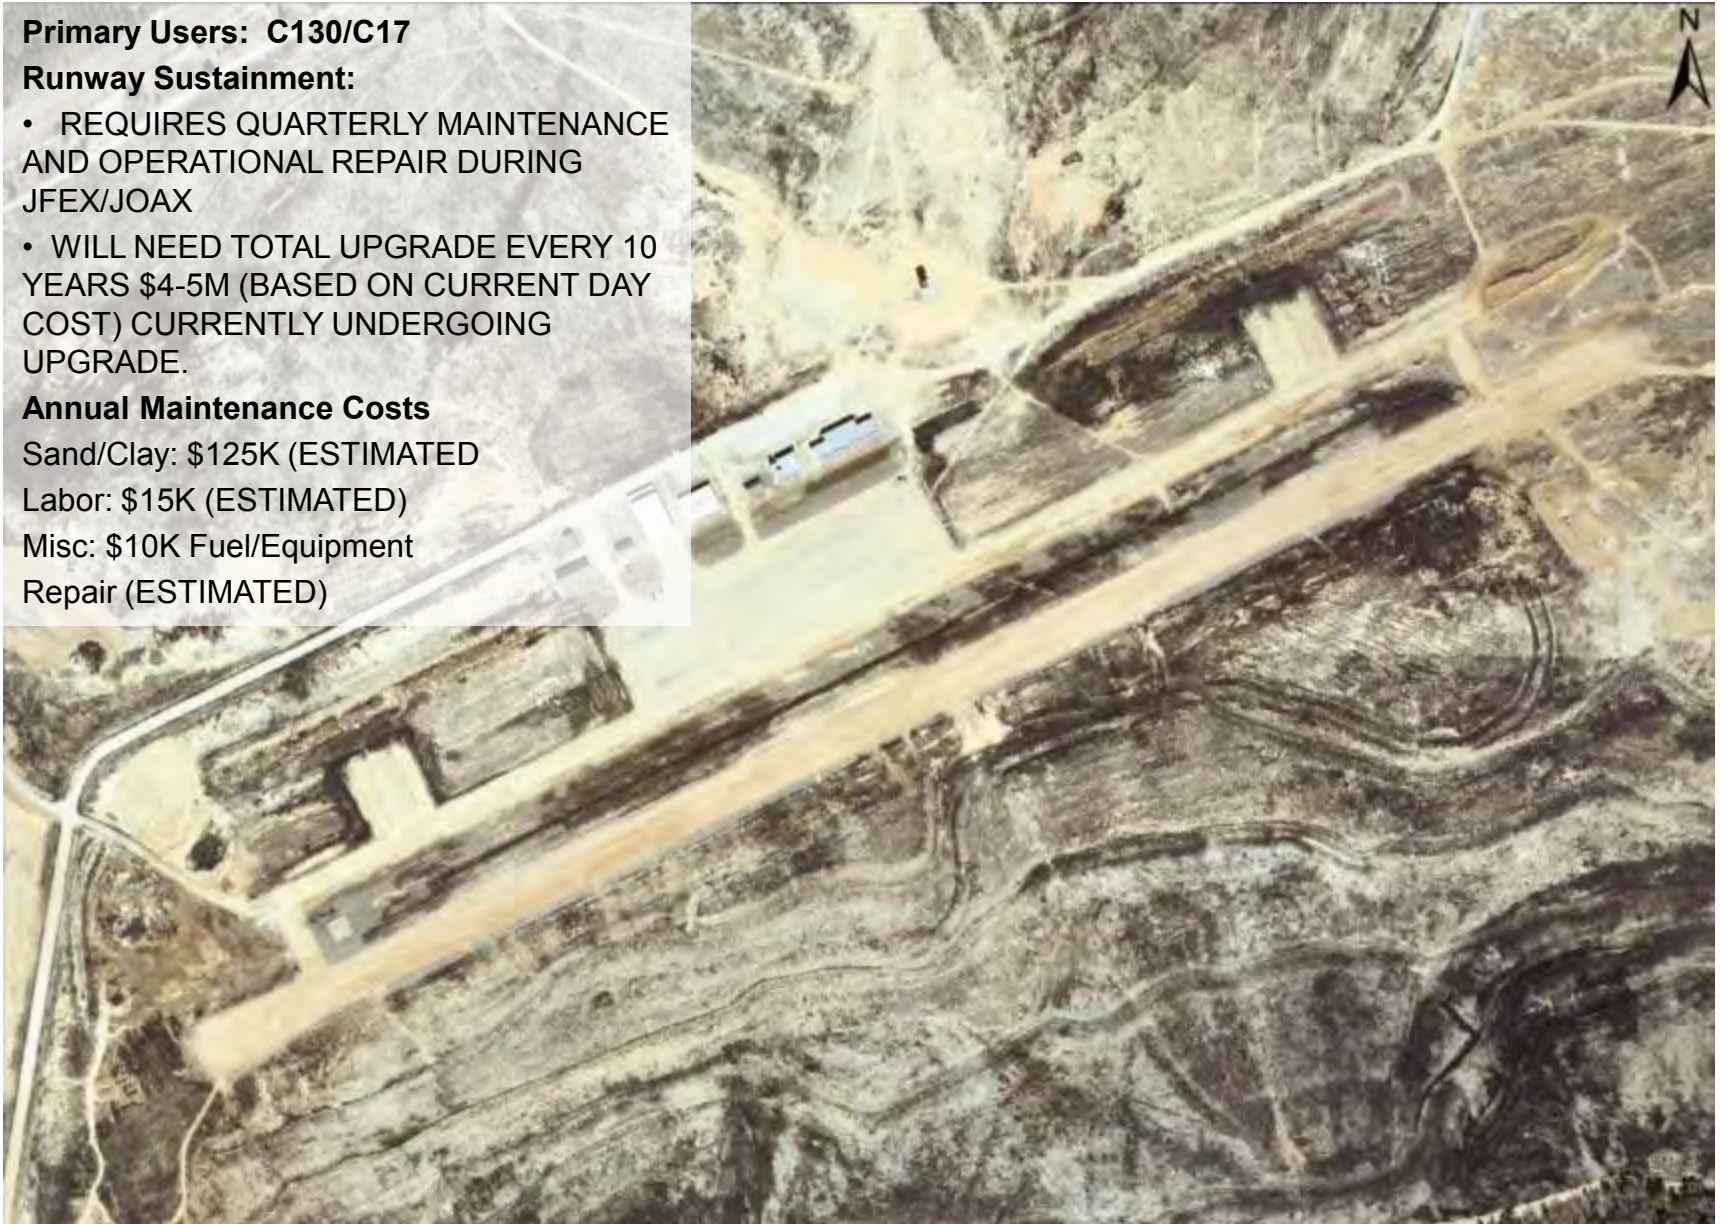
# Holland Overview

**Primary Users: C130/C17**

- REQUIRES QUARTERLY MAINTENANCE AND OPERATIONAL REPAIR DURING JFEX/JOAX
- WILL NEED TOTAL UPGRADE EVERY 10 YEARS \$4-5M (BASED ON CURRENT DAY COST) CURRENTLY UNDERGOING UPGRADE.

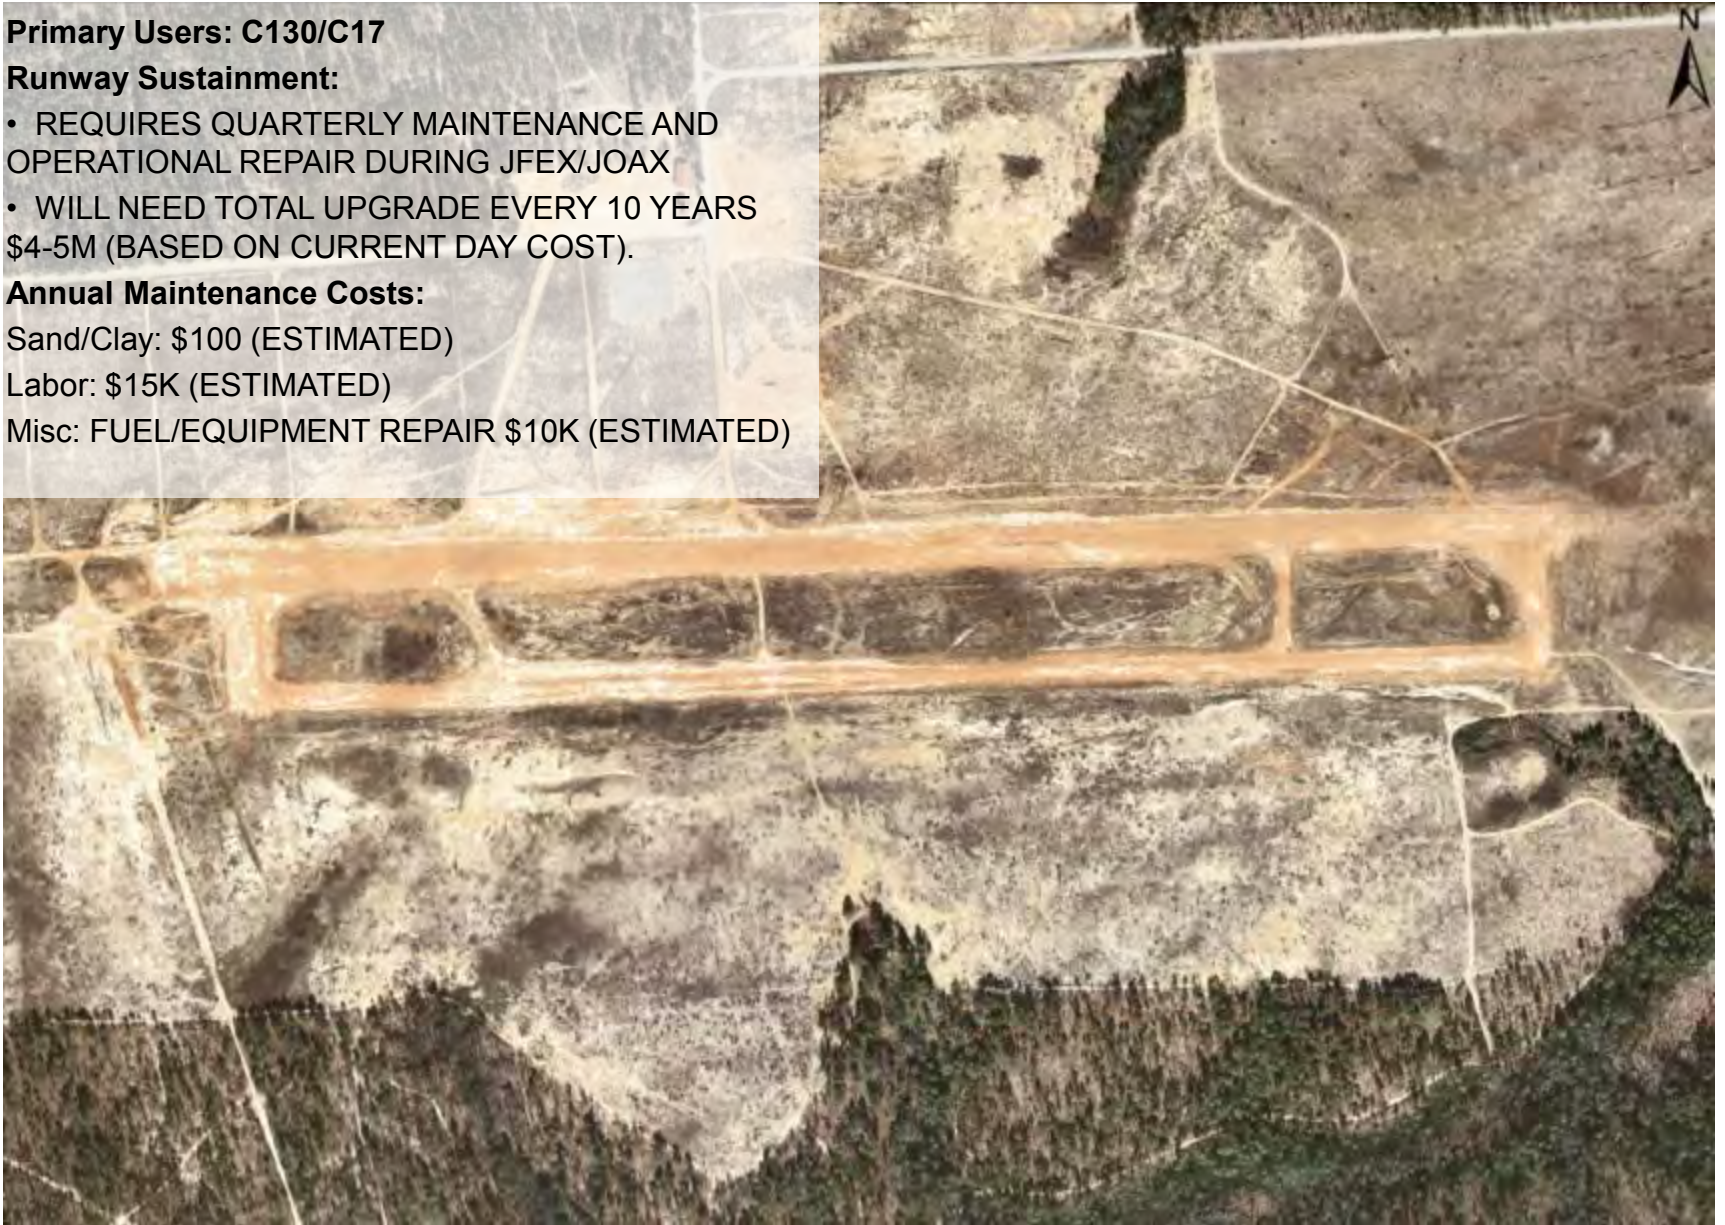
# Rhine Luzon Overview

**Primary Users: C130/C17**

- REQUIRES QUARTERLY MAINTENANCE AND OPERATIONAL REPAIR DURING JFEX/JOAX
- WILL NEED TOTAL UPGRADE EVERY 10 YEARS \$4-5M (BASED ON CURRENT DAY COST).

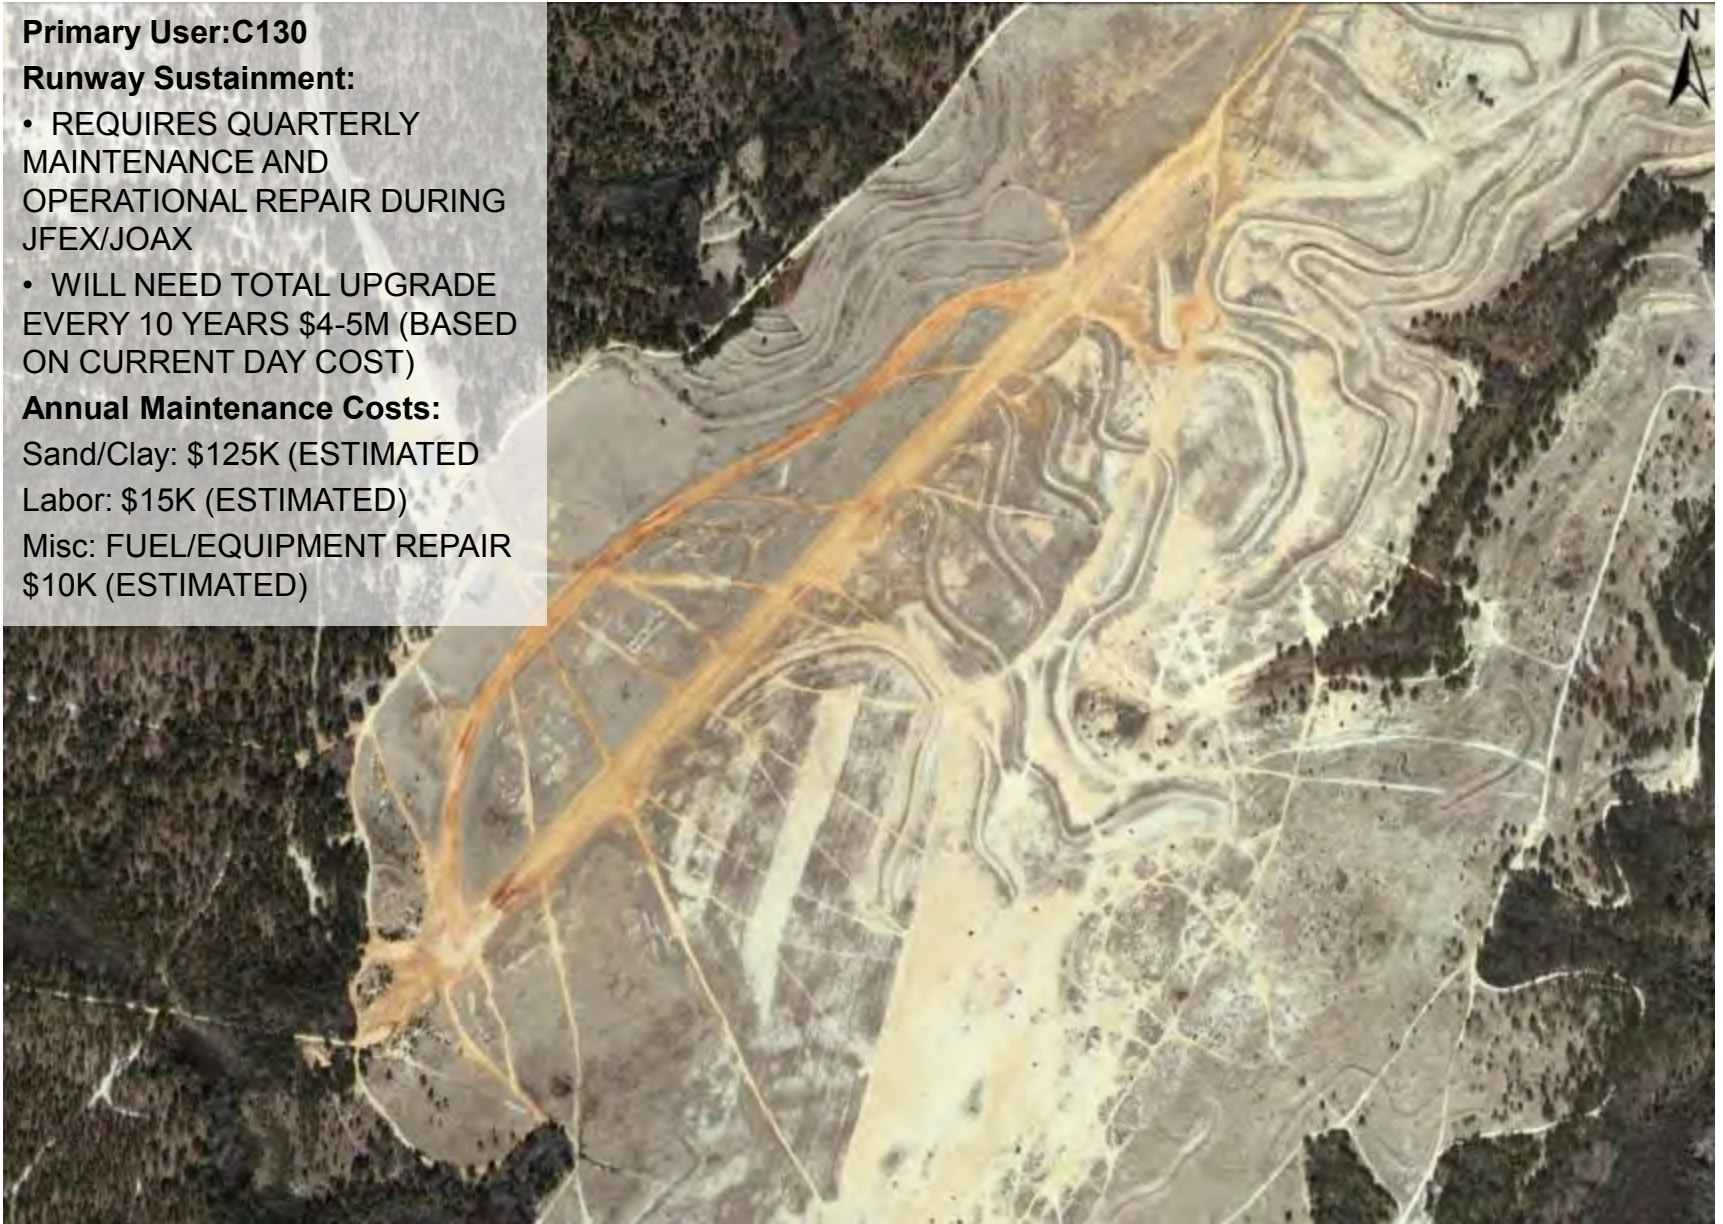
# Sicily Overview

**Primary User: C130**

- REQUIRES QUARTERLY MAINTENANCE AND OPERATIONAL REPAIR DURING JFEX/JOAX
- WILL NEED TOTAL UPGRADE EVERY 10 YEARS \$4-5M (BASED ON CURRENT DAY COST)

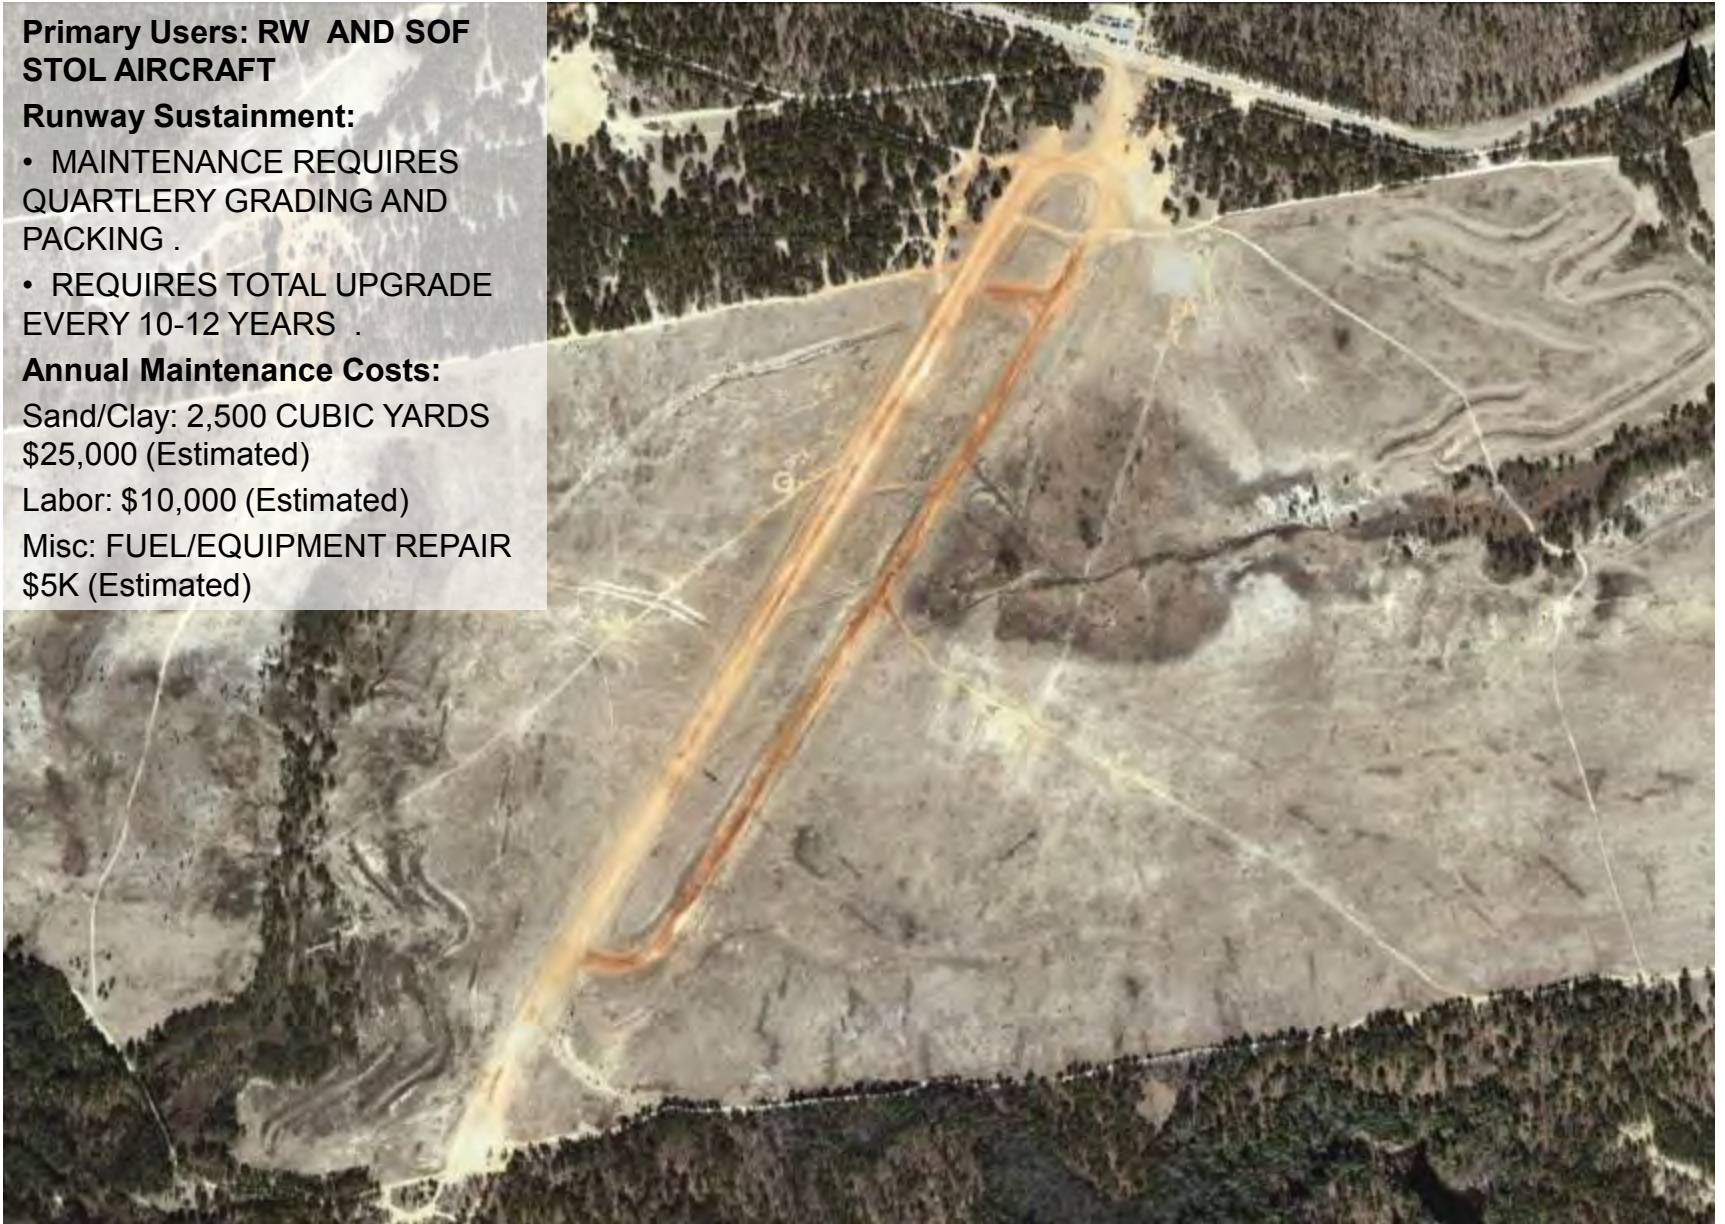
# St Mere Overview

**Primary Users: RW AND SOF  
STOL AIRCRAFT**

- MAINTENANCE REQUIRES QUARTLRY GRADING AND PACKING .
- REQUIRES TOTAL UPGRADE EVERY 10-12 YEARS .
