## **FAC 1166 Miscellaneous Airfield Pavement, Unsurfaced**

# Unpaved Runway Sustainment Funding

25 Aug 2011

To provide information and considerations related to sustainment of Unpaved Runways

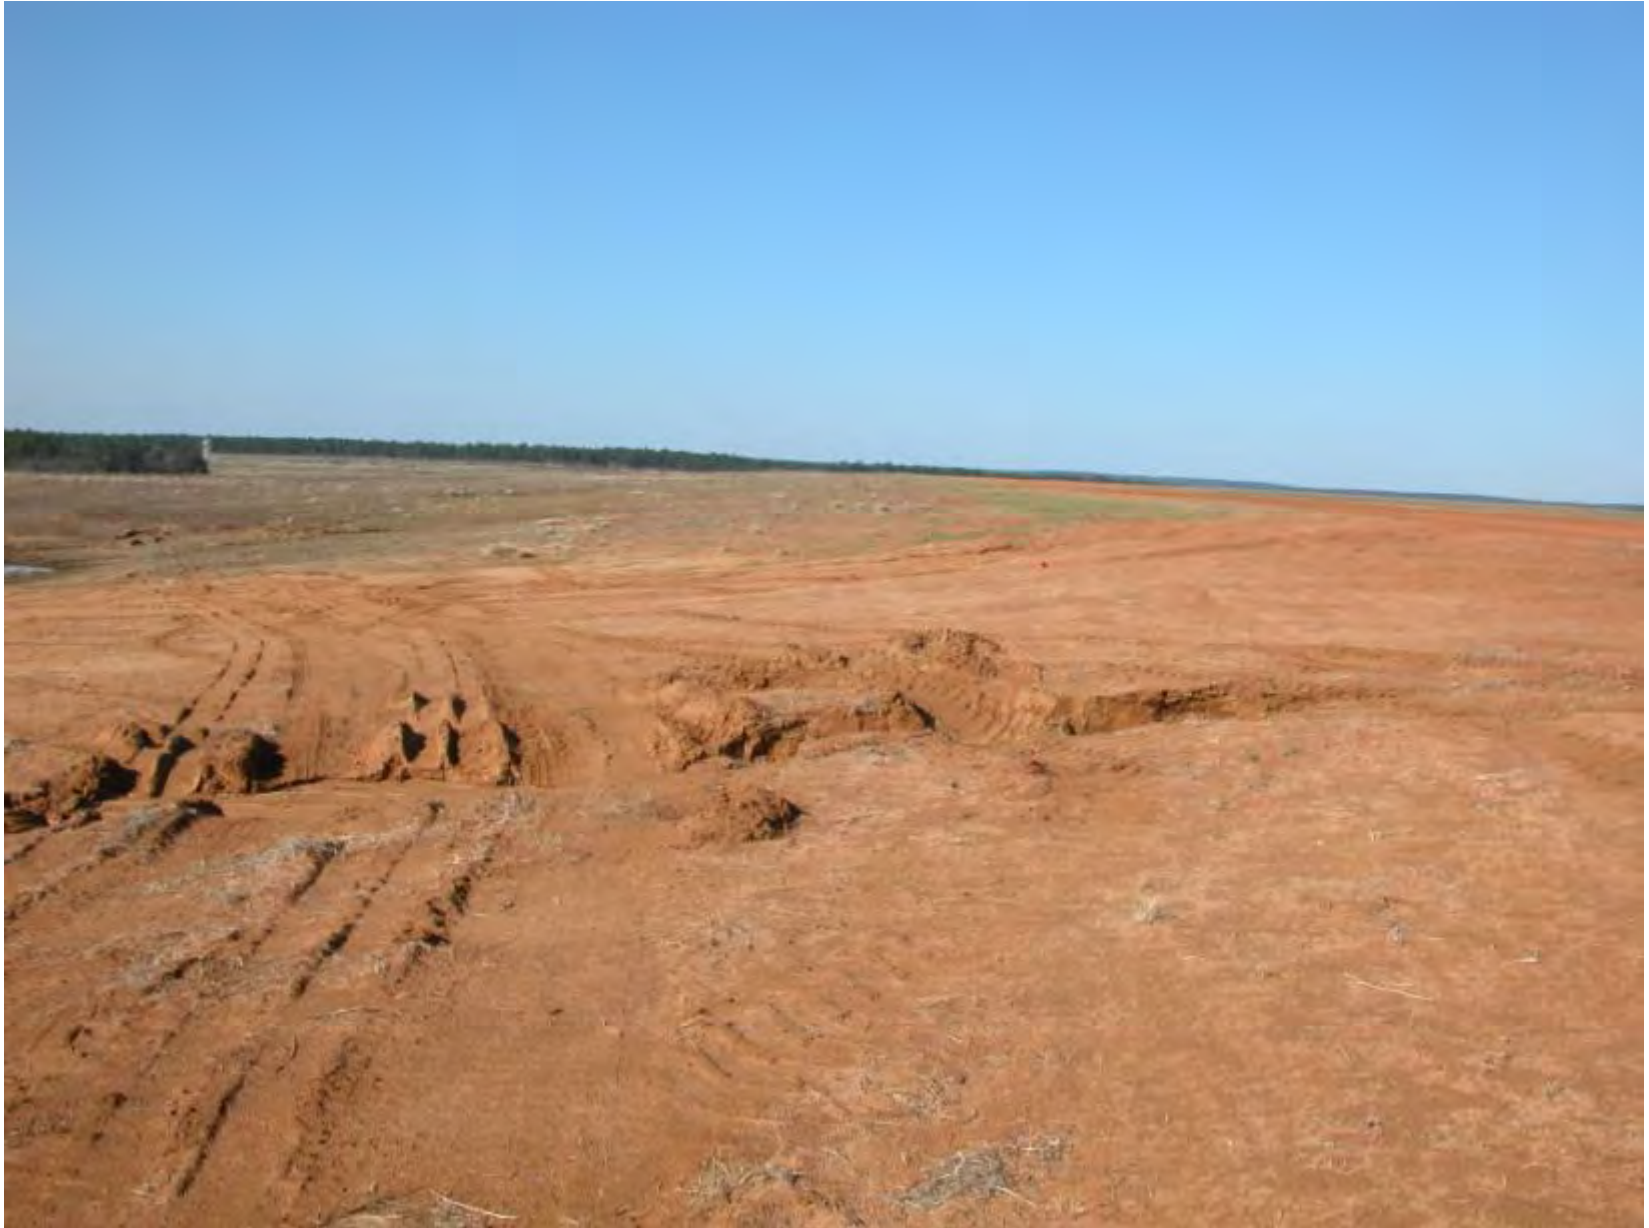
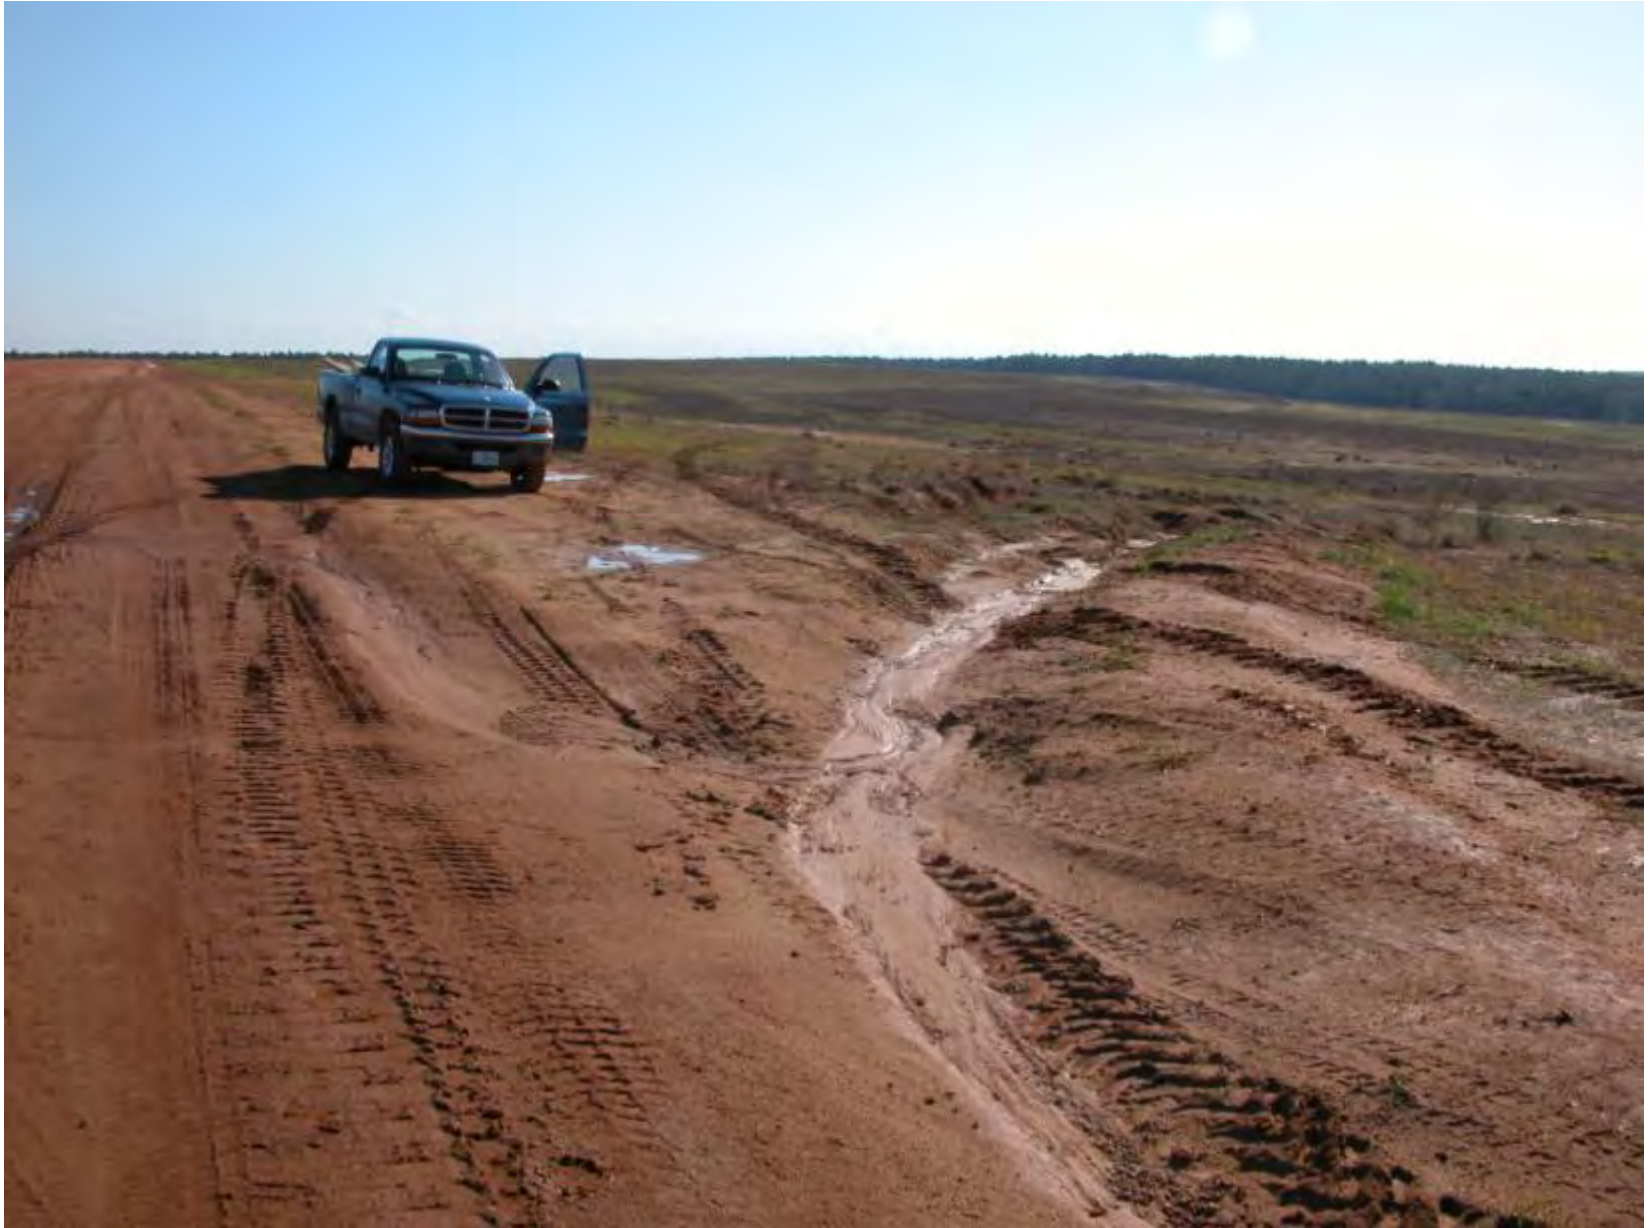
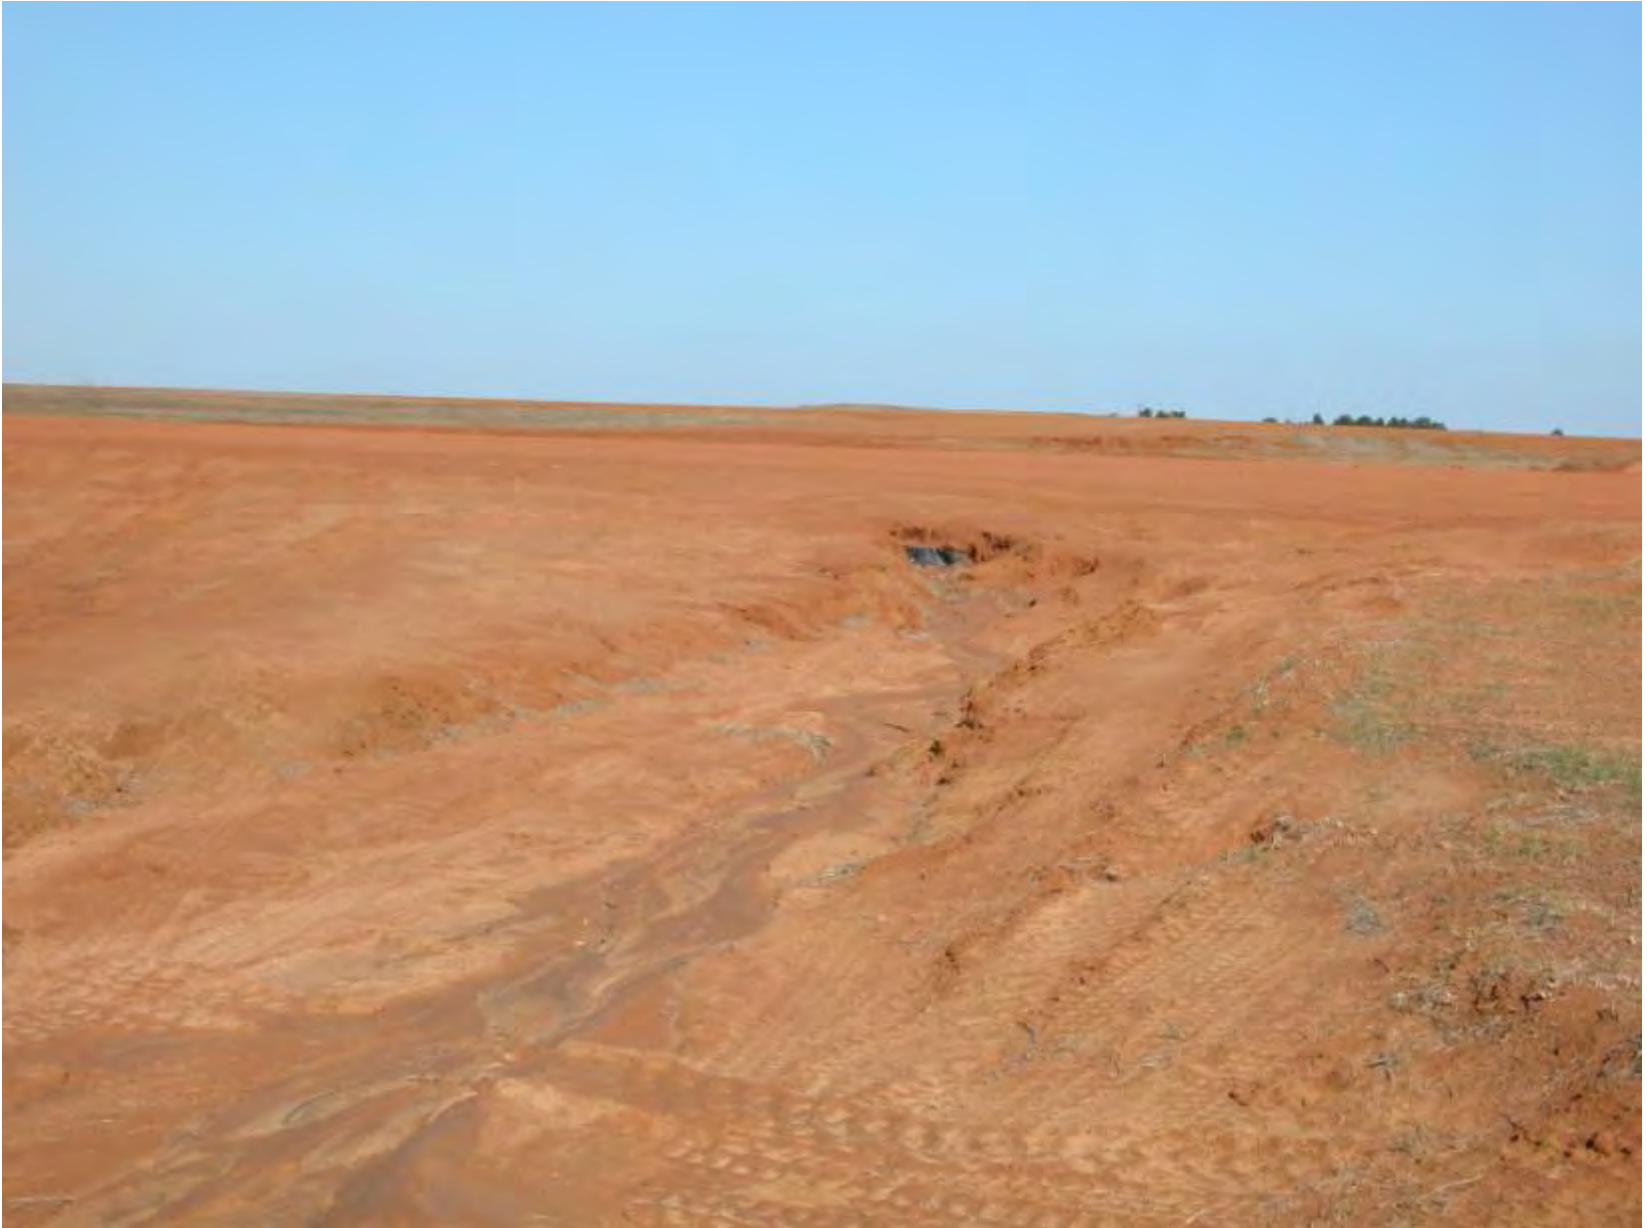
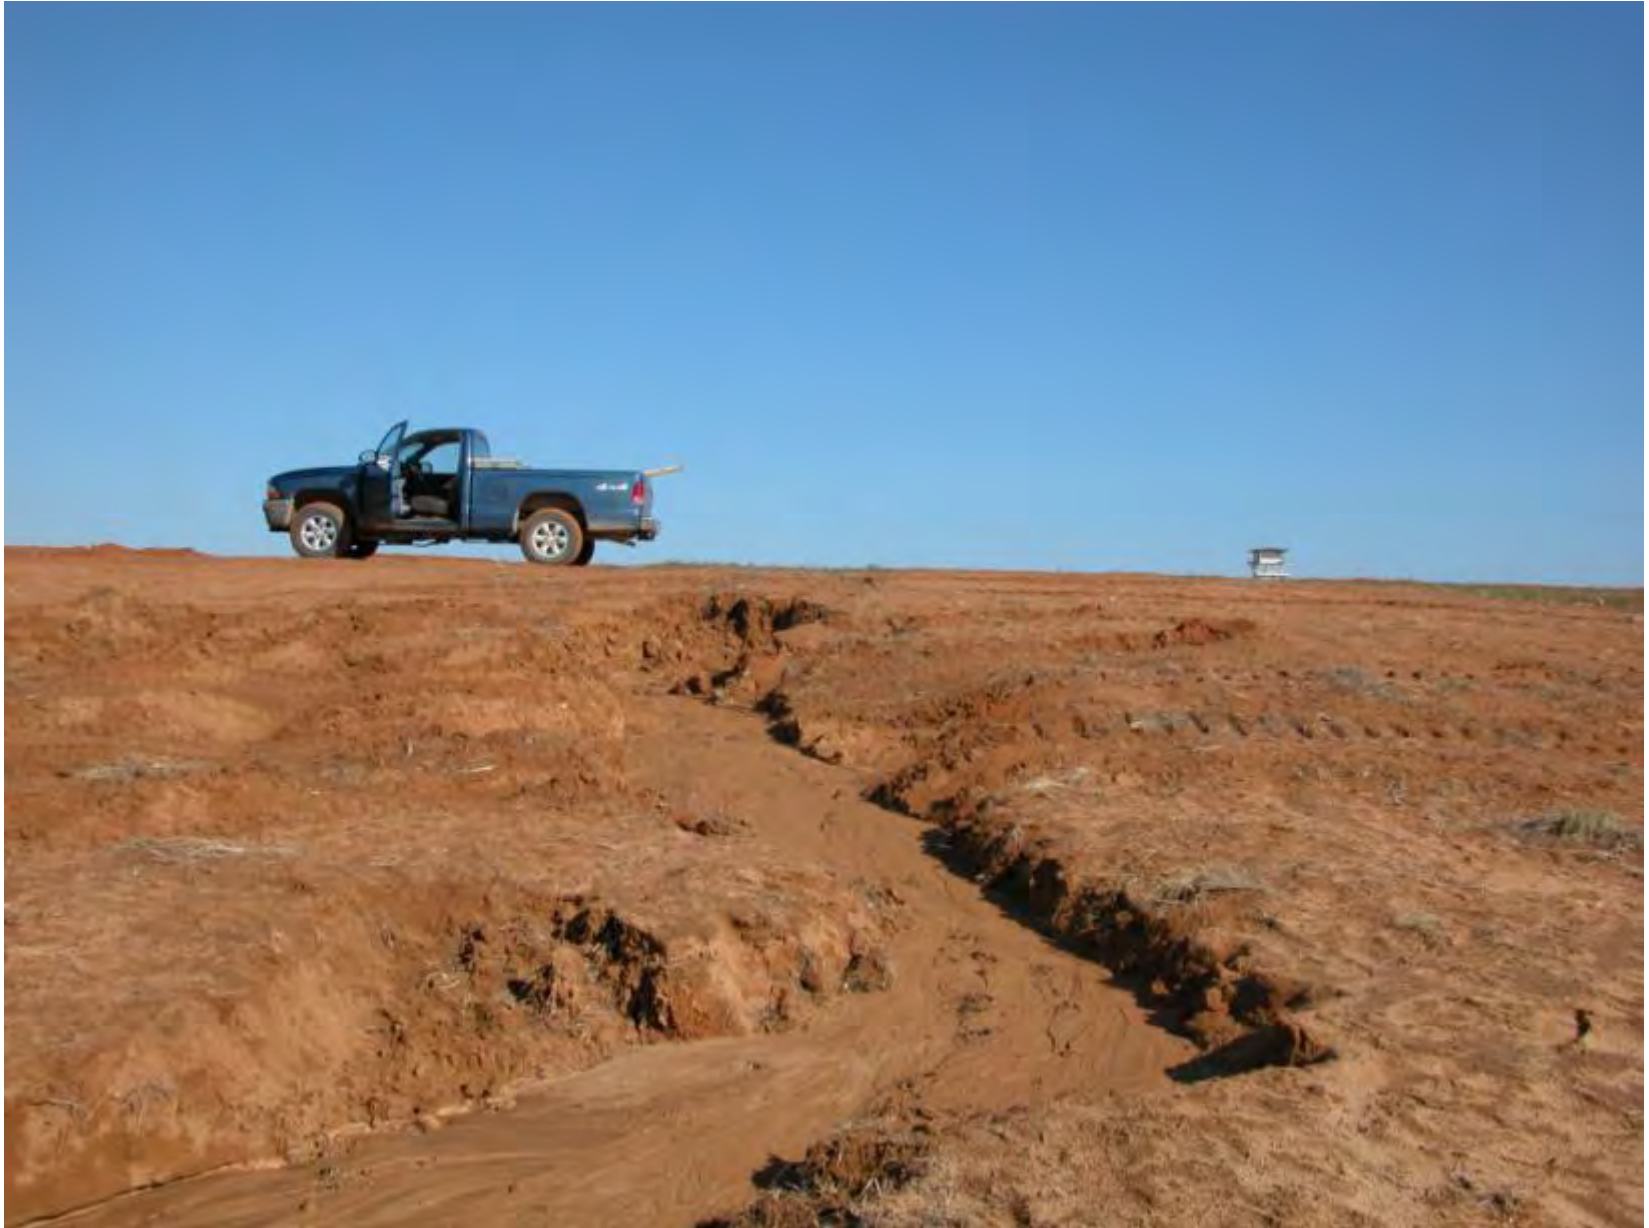
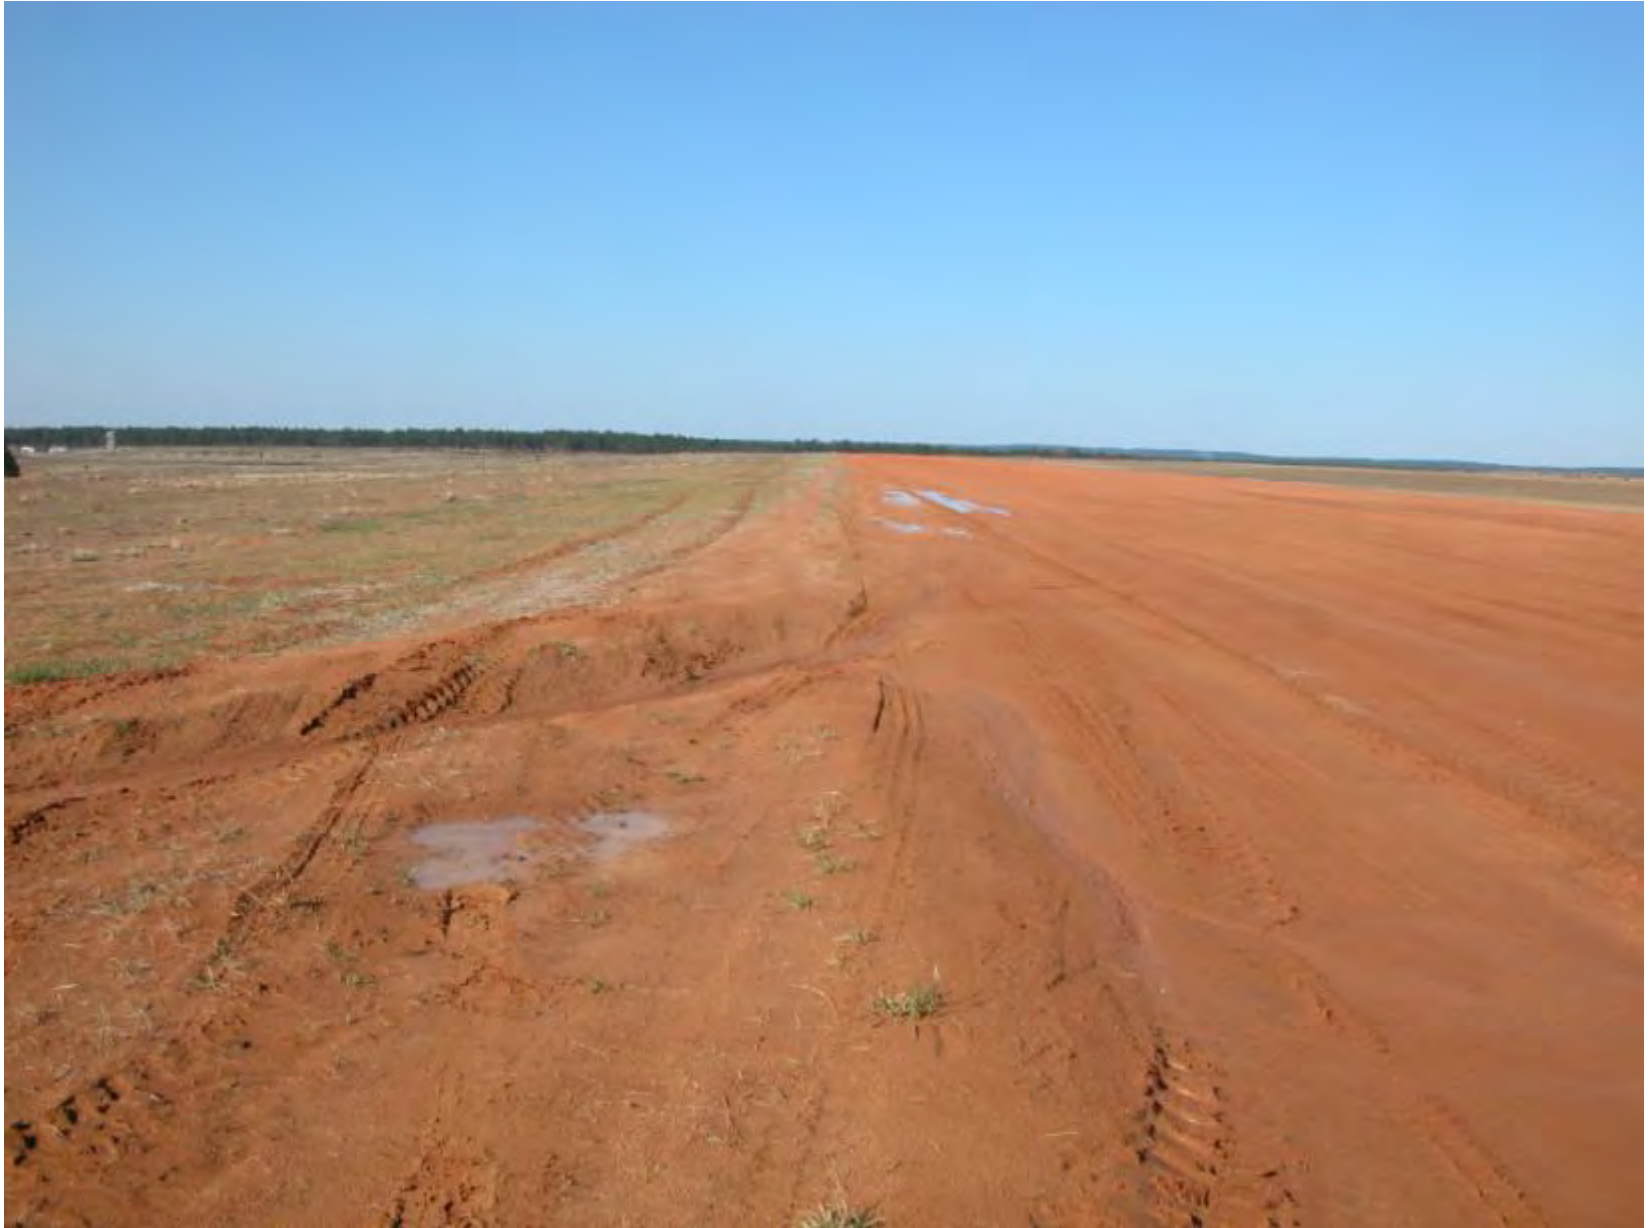
# Fort Bragg Erosion Examples

- A 500,000lb aircraft landing at 120kts/2Gs causes significant runway damage as do 4 engines each producing 14,400lb of thrust.
- While this is an Army-wide issue, FBNC provides an excellent case study:
